CRESCENT LAKE DAM

NDI NO. PA-00413

PIKE COUNTY, PENNSYLVANIA

PHASE I INSPECTION REPORT
NATIONAL DAM INSPECTION PROGRAM

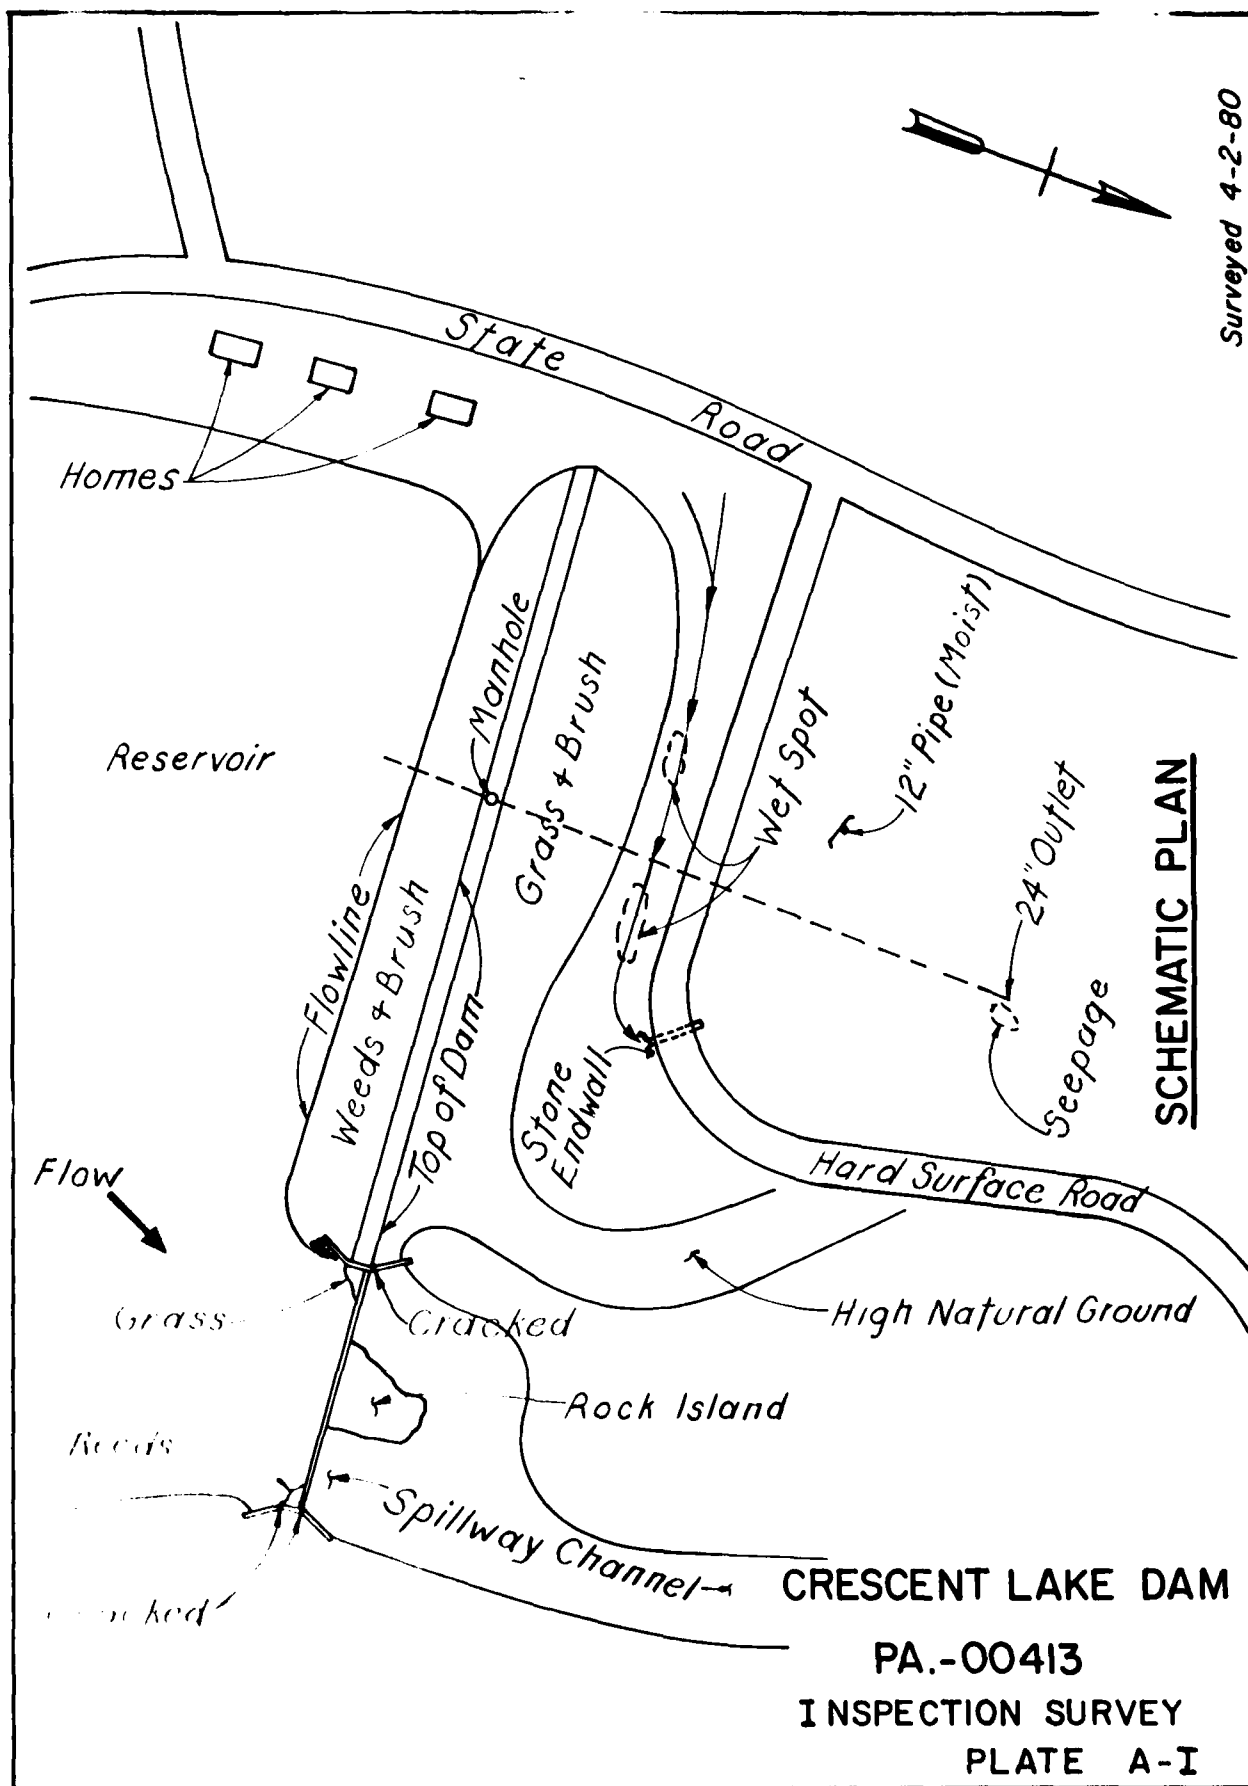
SCHEMATIC PLAN

| | OBSERVATIONS AND REMARKS |
|---|--|
| C. DISCHARGE CHANNEL: Lining Cracks Stilling Basin | An island of rockbutts against the weir near the center of its length on the downstream side. Refer to Plate No. A-I, Appendix A. The entire discharge channel is lined with large rocks and boulders. |

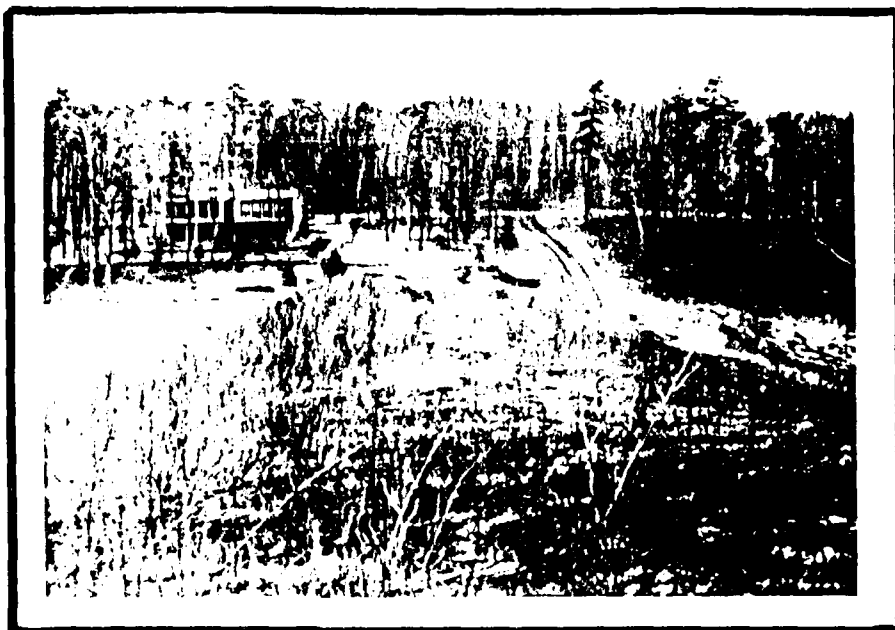
LEFT END OF EMBANKMENT - NO. 2
NOTE: WEEDS AND BRUSH

The operational procedures for Crescent Lake Dam are minimal at the present time. It is recommended that a program be developed for regular maintenance of the dam, which should include the removal of weeds and brush, the clearing of the spillway forebay area and the greasing and operation of the drawdown valve on a regular basis. A formal surveillance plan and downstream warning system should be developed for implementation during periods of heavy or prolonged precipitation.

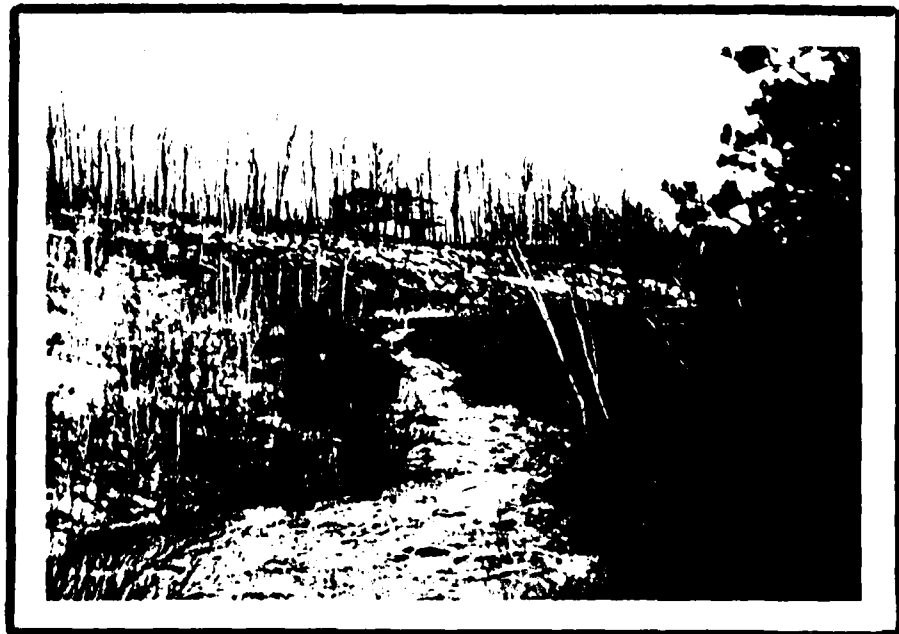
The immediate downstream channel of the spillway is steep with large boulders and steep side slopes. A bridge crosses the channel about 400 feet downstream of the dam. The vertical clearance is more than adequate for the expected runoff. Three homes are located about a quarter-mile downstream of the dam, and a state highway bridge crosses the creek about half a mile downstream of the dam. A potential hazard to loss of life exists downstream if the dam fails. The hazard category is therefore considered to be "High."

DOWNSTREAM CHANNEL LOOKING UPSTREAM FROM BRIDGE - NO. 7
